Towers Withstood Impact, But Fell to Fire, Report Says

The report's findings detail for the first time the horrific series of events that led to the collapse of two of the world's tallest buildings. They are contained in a draft of a report commissioned by the Federal Emergency Management Agency and the American Society of Civil Engineers.

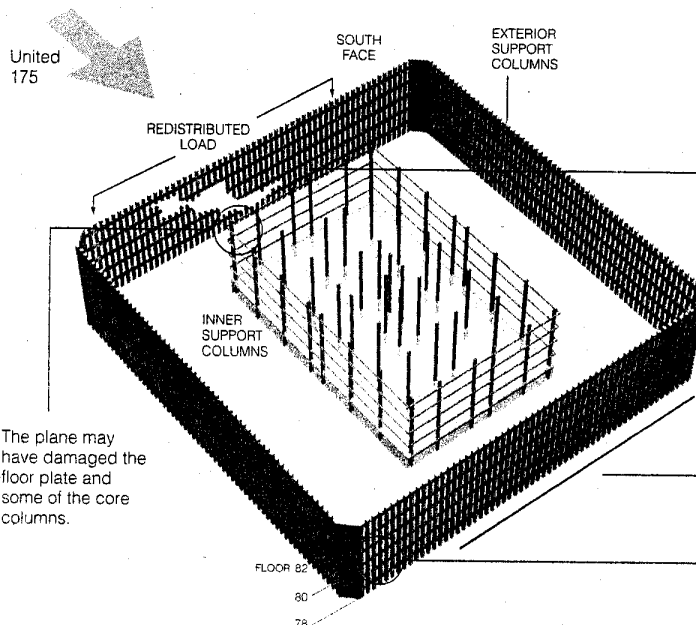
South Tower

IMPACT 9:02:54 a.m.

Initially, floors near the impact suffered severe damage across a horizontal span of about 70 feet.

As the plane plowed through the building, it created a cloud of jet fuel that ignited into fireballs, burning an estimated 1,000 to 3,000 gallons of jet fuel. The pressure was sufficient to break windows, but not enough to cause significant structural damage.

People on the 91st floor described extensive debris in the eastern part of the central core. This suggests a partial collapse of framing in the central core.

Floors supported by the missing sections of exterior walls appear to have partly collapsed across a horizontal span of about 65 feet.

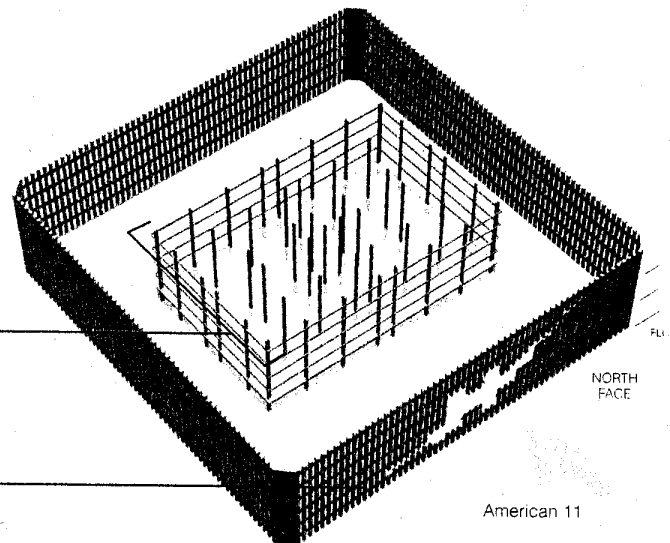
The Impact

Some debris went completely through the buildings and landed as far as six blocks away. Life jackets and parts of seats were found on the roof of a nearby building.
